# **ELASTOMERIC TANK LIFE EXTENSION STUDIES - Part II**

**INTERIM REPORT  
TFLRF No. 326**

**G. E. Fodor  
U.S. Army TARDEC Fuels and Lubricants Research Facility  
(SwRI)  
Southwest Research Institute  
San Antonio, Texas**

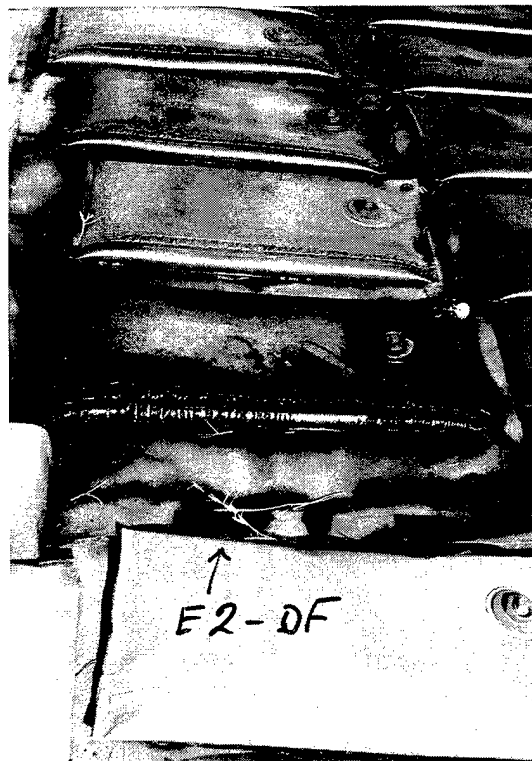
**Photograph 21. Diesel fuel-filled sacrificial pillow tanks two years after deployment**

The visual observations are documented in photographs 16-21. Photographs 16-18 show the newly deployed (a) empty control or blank tanks, (b) turbine fuel-filled tanks, and (c) diesel fuel-filled sacrificial pillow tanks, respectively. Photographs 19-21 show the same set of sacrificial pillow tanks approximately two years after deployment. Three of the diesel fuel-containing E-2 minitanks exhibited major delamination of the coating polymer from the nylon fabric. One such pillow tank is pictured in Photograph 22.
